Final Report of the Silicon Lifetime Committee

The Silicon Lifetime Committee was charged with systematically identifying limitations to the operational lifetime of the present silicon detectors, SVX II, ISL, and L00. In this note the work and conclusions of this committee are summarized.

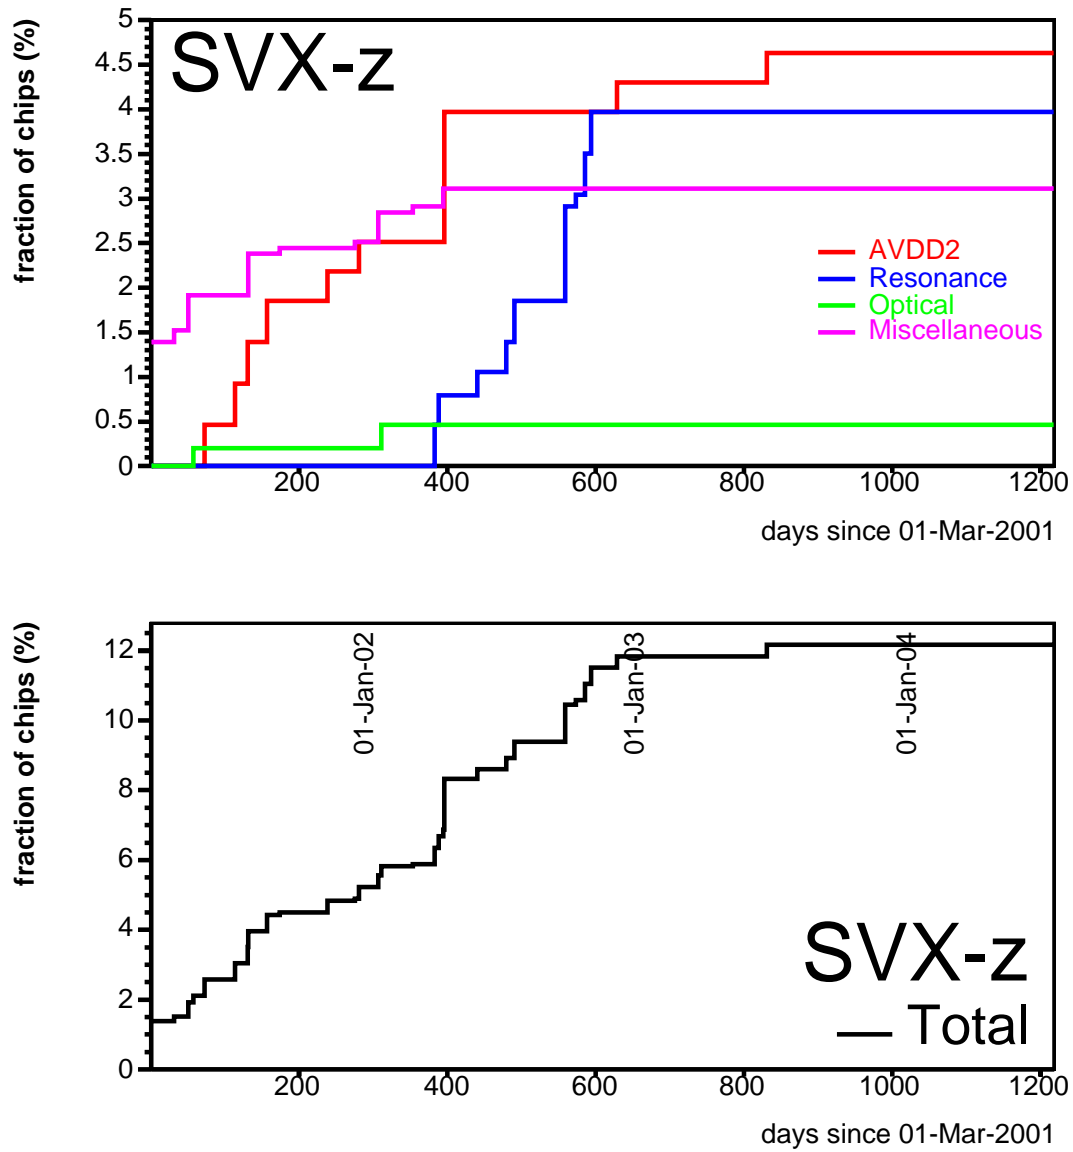
Figure 3: Damage history of the SVX- z side, expressed as the fraction of readout chips which are inoperable. The AVDD2 failures are mostly due to beam incidents and/or thermal cycles.

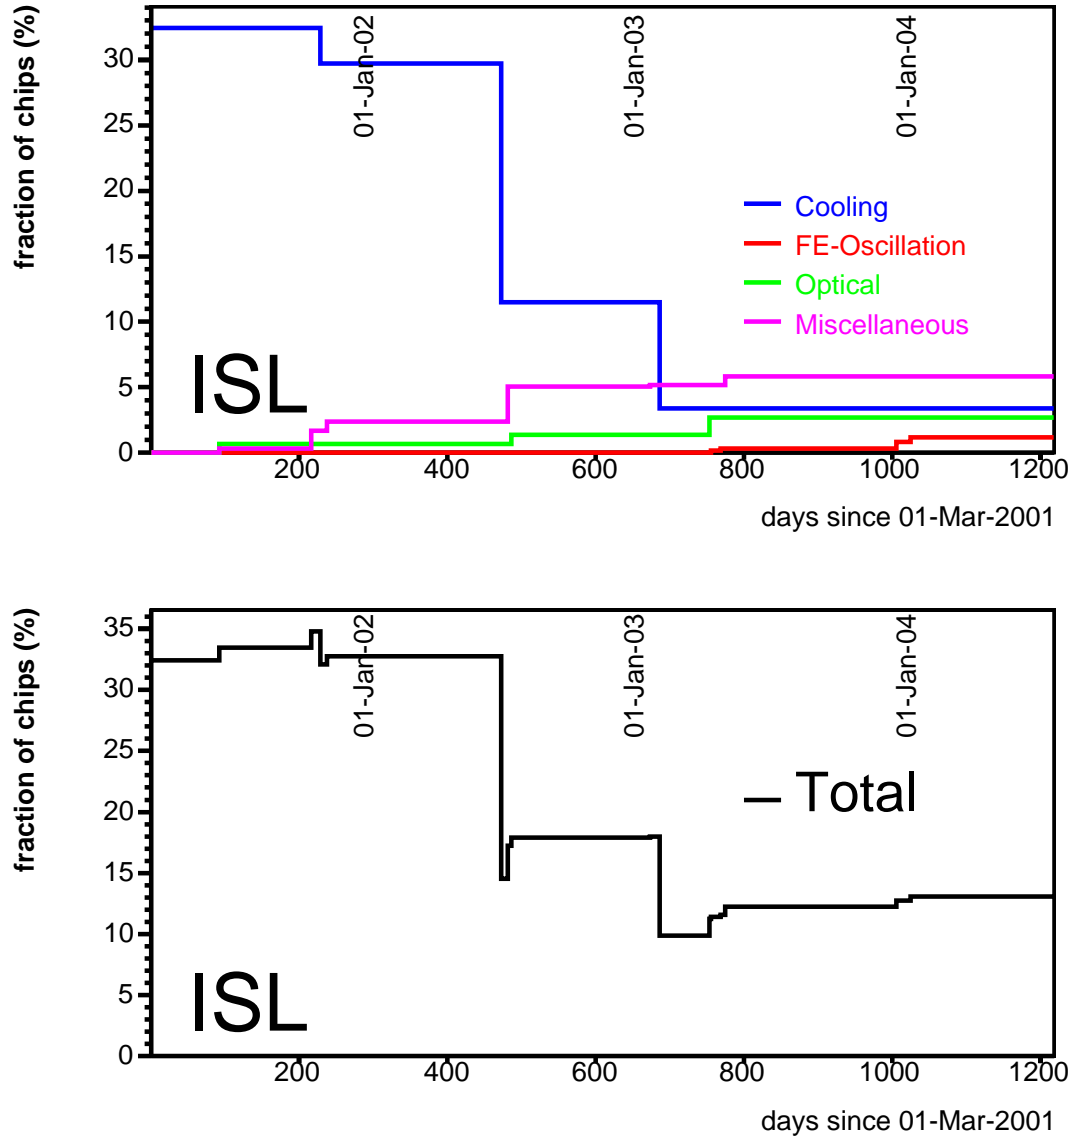
The ISL damage history is shown in Figure 4. There are two major sources of lost data, the cooling blockage and “Front-End Oscillations” (FE-Oscillations). Although most of the blocked cooling lines were recovered, 1 blocked line remains. There is little chance that it will ever be opened. A concerted effort may be able to determine operating parameters which would allow at least a partial recovery of the affected 10 ladders. The FE-Oscillation failures, like the AVDD2 failures, are most always associated with beam accidents. No concerted investigation has been made to understand these failures. They are the major source of continuing ISL failures.

Figure 4: Damage history of ISL (ϕ and z), expressed as the fraction of chips which are inoperable. The cooling failures are due to the epoxy blockages. The FE-Oscillations may be beam related.

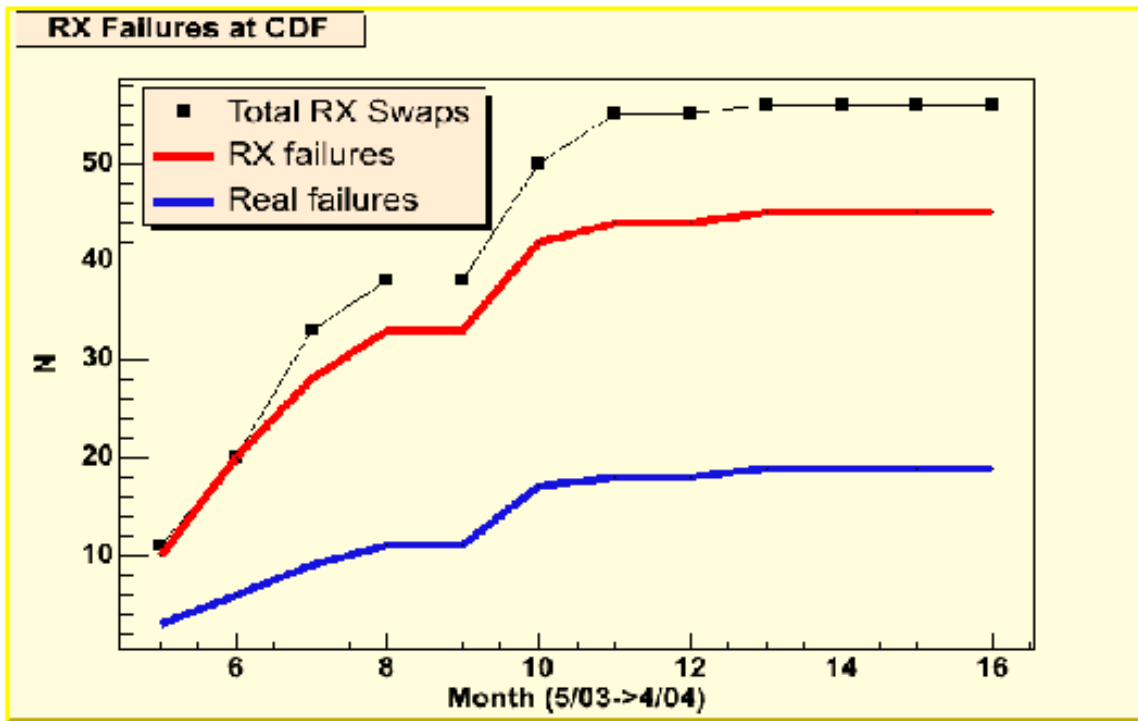
Figure 5: History of DOIM RX failures. Most failures are repaired at PREP and returned to the spare pool. The number of failures fell dramatically after gold-plating the connection pins in Oct-2003.
